## PRODUCT EVALUATION 86-18 JOINT SEALANT STUDY

**Construction Report**

JOINT SEALANT STUDY
CONSTRUCTION REPORT

**JANUARY 7, 1987**

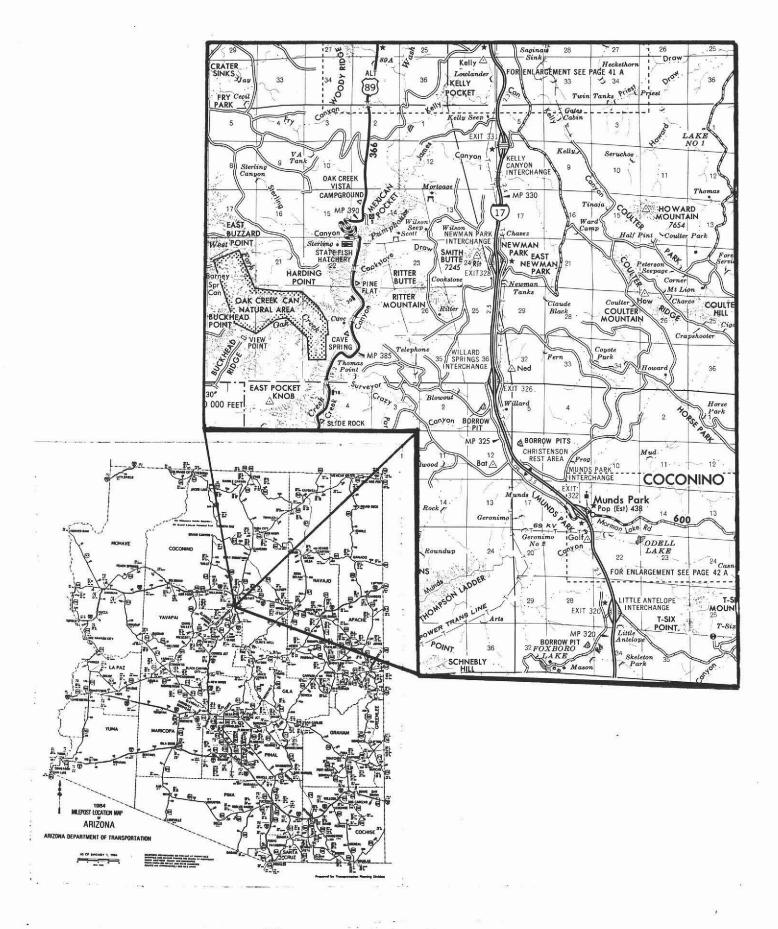
Figure 1- Location of Test Section

An advertisement for bid, IR-17-2(104), was let March 28, 1986, to reseal 26 miles of plain jointed portland cement concrete pavement on the southbound lanes of I-17, south of Flagstaff (Figure 1). The joint sealant selected for the resealing project was Superseal 444, a hot-pour material produced by Superior Products. A copy of ADOT's joint sealant specifications for this project is included in Appendix A.

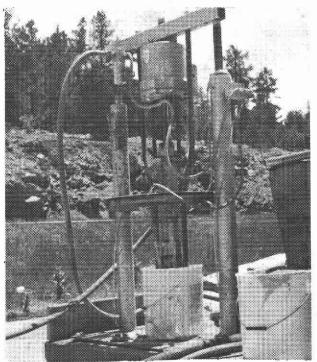
Figure 5- Pump for Silicone Material

After the joints were prepared the backer rod was placed approximately 1/2 inch from the top of the slab. The silicone was supplied in five gallon buckets and placed by an air driven pump. After placement, it was immediately tooled with a rubber hose on the end of a broom stick. The tooling was necessary to ensure that the sealant was below the surface of the joint. Figures 5, 6, and 6 are photos of typical silicone joint sealant placement. A four man crew was used to place the material: a driver, an operator for the injection, a tooler, and a clean-up person.

Superior Products was unable to supply their material in time for the two-day project. The Superseal 888 product was placed on the 14th of July in the passing lane and on the 25th of July in the driving lane. The equipment and installation procedure was the same as for the Dow Corning 888. Prior to placing the product, the pump had to be purged, so as not to contaminate the material with the previous Dow Corning 888. Figures 5, 6, and 7 are photos of typical silicone joint sealant placement.
